# **REPORT ON SCHOOLS SELECTED FOR SEISMIC RETROFITTING IN EACH DISTRICT OF DELHI**

## **Introduction**

## **Brief Description of the Project**

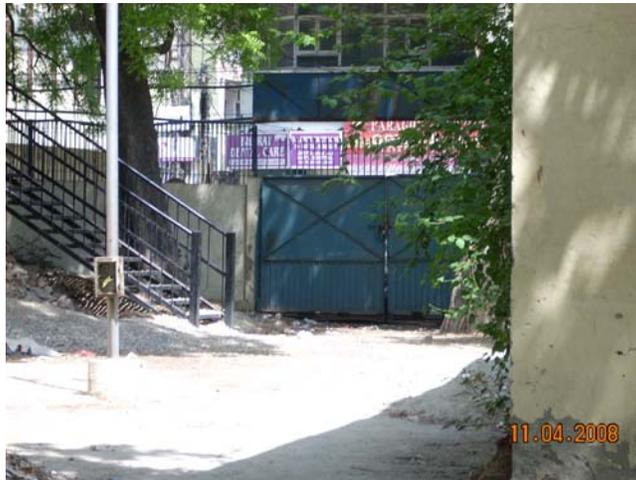
In the first look the buildings condition is good and is regularly maintained by PWD. Building 5 is under renovation and the masons are making the second door for the single door class rooms. The school has two exit doors one of them is permanently closed as it opens to a parking area of the market surrounding the school.

(The permanently looked exit)

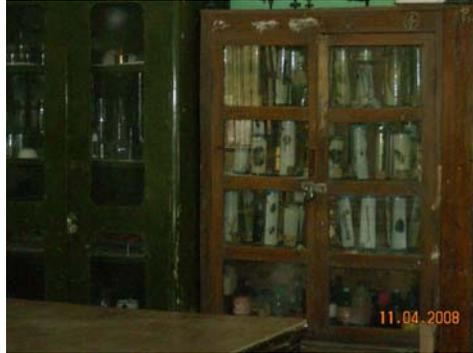
- (a) Laboratories: Chemistry, Biology & Physics practical are all held in the same room. The specimen, chemicals and the physics equipment are hence stored together. This makes the laboratory particularly vulnerable to fire /

explosion during earthquakes. The presence of a number of LPG cylinders used for conduct of practical increases the vulnerability of this compartment during disasters. However, the presence of a number of fire extinguishers stowed properly in the room reduces the risk to a certain degree.

(Biology/Chemistry Lab)

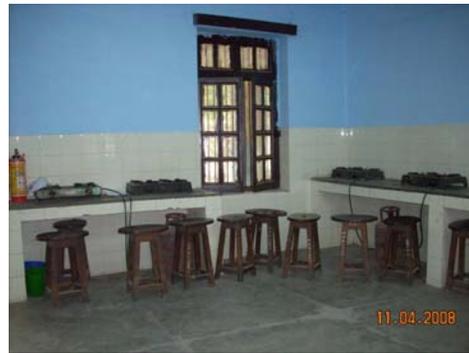
(Home Science Lab)

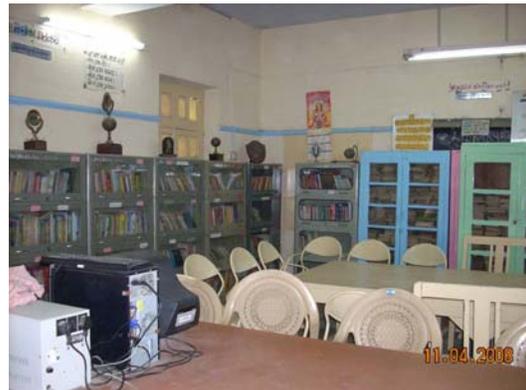
(b) Library: The cupboards in which the library books are stowed have glass doors thereby increasing the hazards.

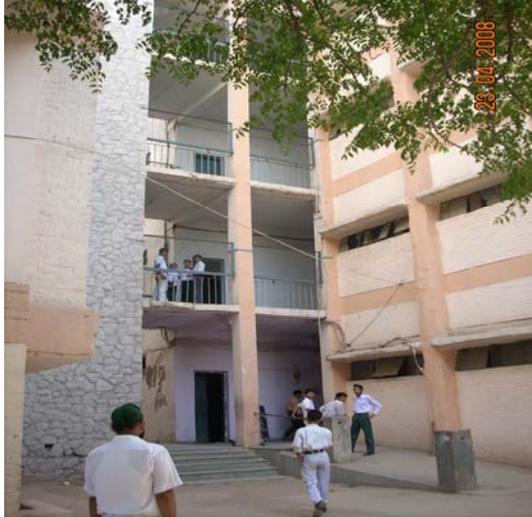
*Building 1:* The main building of pucca construction has four storeys and two basements. There are two staircases on both the sides of the building. The building has 6 rooms on each floor, hence 3 rooms on each side of the main passage. The passage has one big room on each floor used as laboratories for various streams. There are a total of 24 class rooms and 18 other rooms (library and laboratories etc) in the main buildings.

(The building 1 with passage and the two wings)

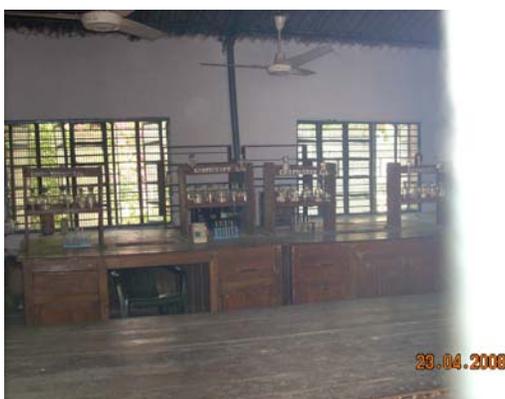
(a) Laboratories: The school has separate Chemistry, Biology & Physics laboratories. The specimens, chemicals and the physics equipment are hence stored together. This makes the laboratory particularly vulnerable to fire / explosion during earthquakes. The presence of a number of LPG cylinders used for conduct of practical increases the vulnerability of this compartment during disasters. However, the presence of a number of fire extinguishers stowed properly in the room reduces the risk to a certain degree, though the extinguishers are 3 years old and how to use them remains a mystery. The laboratories are spread in the premises. Boys have them in the building 1 and girls have them in tin sheds.

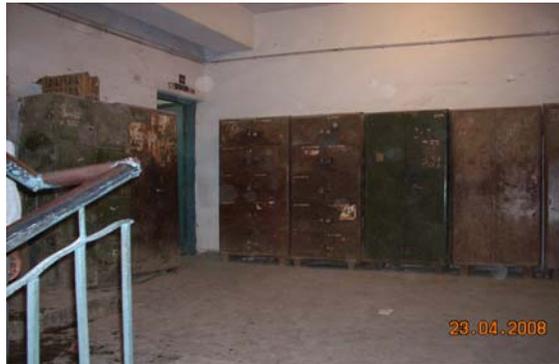
(b) Corridor: The passage on the first floor is used to store the steel cupboards.

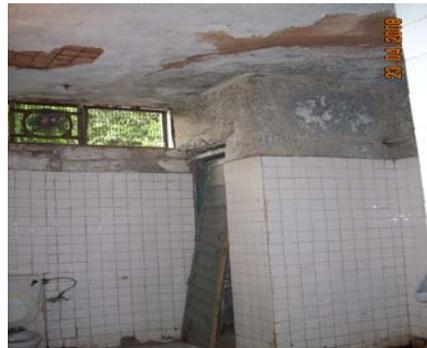
(g) Toilets: The ceiling has plasters falling at several places and the tiles are also not intact.

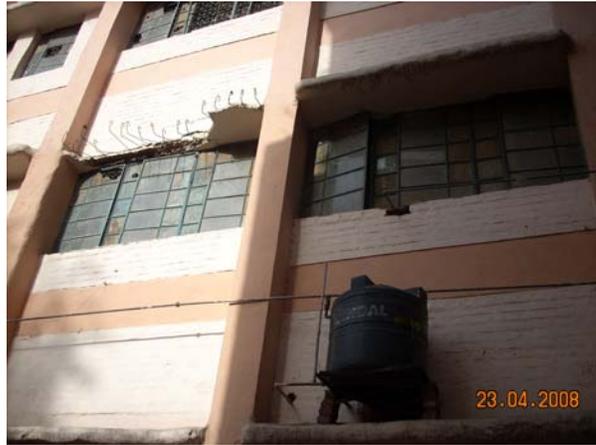
(g) External falling Hazard: Water storage tank is not secured.

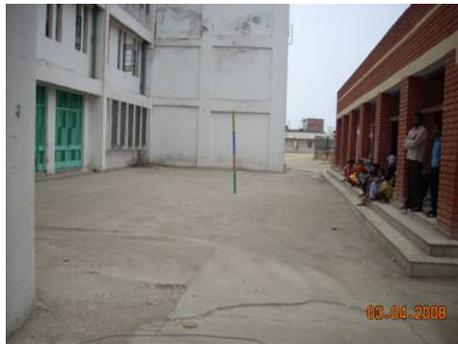
(Building 1 and 2)

The distance between the main building and second pucca construction varies from 2m to 5m at different locations.

The space between the main building and the tin shed is more than 15 m. The space between the main building and the hall is more than 7 m.

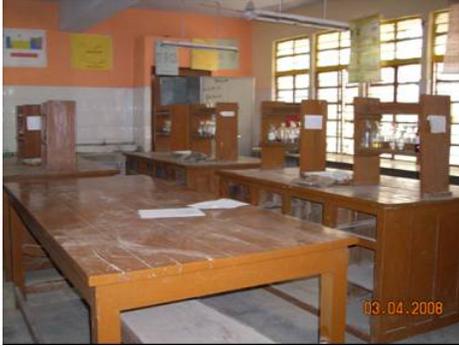
(a) Laboratories: Chemistry, Biology & Physics labs are in separate rooms and are different for both the schools. The specimen, chemicals and the physics equipment are stored in open on the top of the table. There are charts and other training aids all over the room. Maths, home science, social studies, geography and CAL (only for the boys school) laboratory have equipments kept everywhere. All of them also have 2-3 steel cupboards.

(Chemistry Lab)

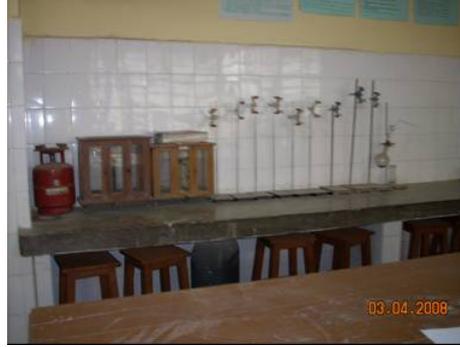
(Physics Lab)

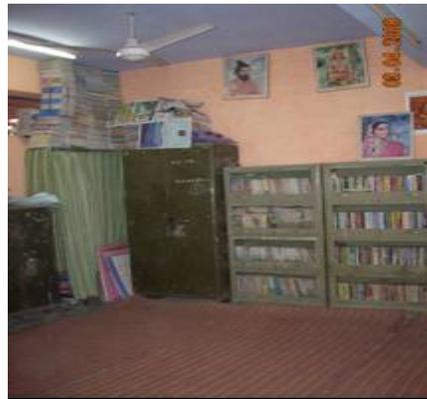
(b) Library: There are two libraries in the whole school and the cupboards in which the library books are stowed have glass doors thereby increasing the hazards, moreover the books are also stacked on these cupboards.

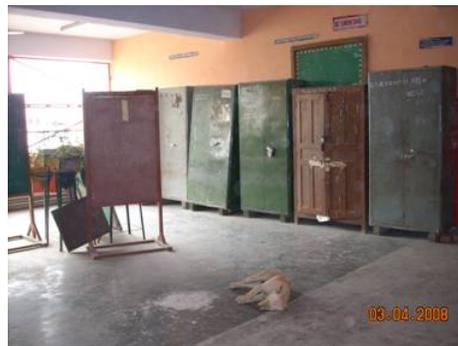
(c) Corridor : The corridors are used as a storage area for the steel cupboards and one can see them every where in the main building.

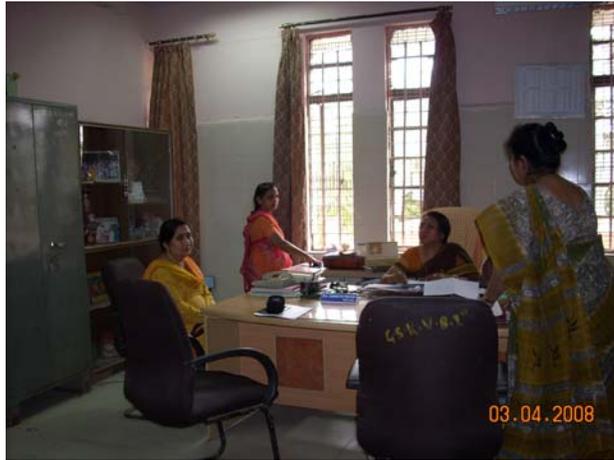
(e) Principal's Room: The Principal's Room has a number of cupboards and trophies which are not secured properly. It also has a television and computer.

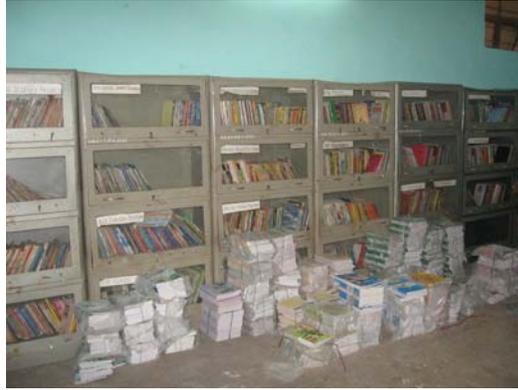
(b) Library: There are two libraries in the whole school and the cupboards in which the library books are stowed have glass doors thereby increasing the hazards.

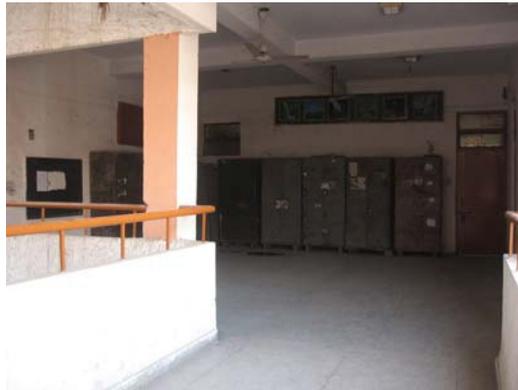
(d) Corridor : The corridors are used as a storage area for the steel cupboards and they are sometimes used for conducting classes.

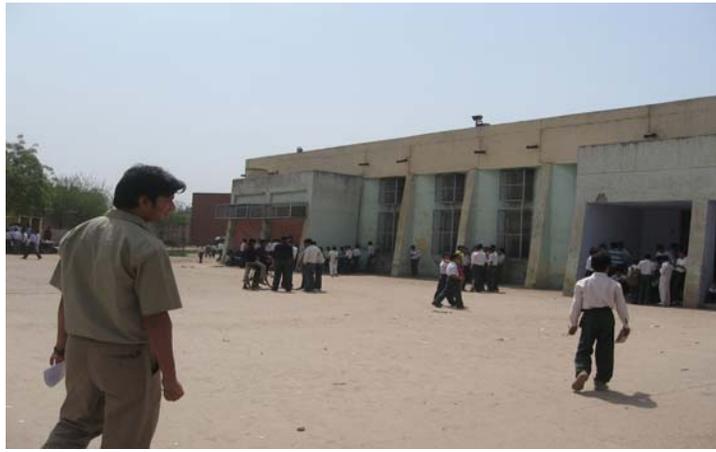
(Open Area)

A big open area is in front of the main building where they have their assembly, and there is a large play ground on the left.

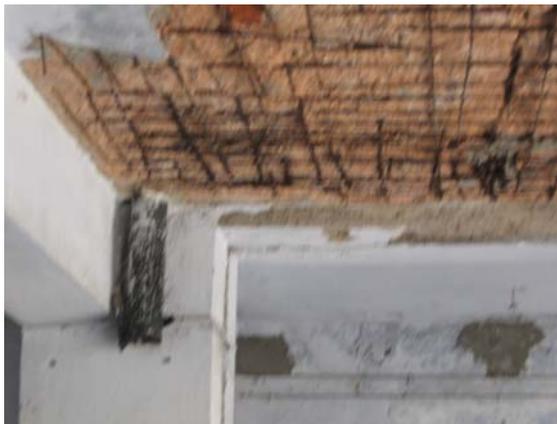
Building 1 has plaster falling at several places and the rusted rods are visible. The stairs are broken at most of the places. At several places in the toilets the ceiling is falling and the tiles are also not intact.

(Ceiling in the lobby)

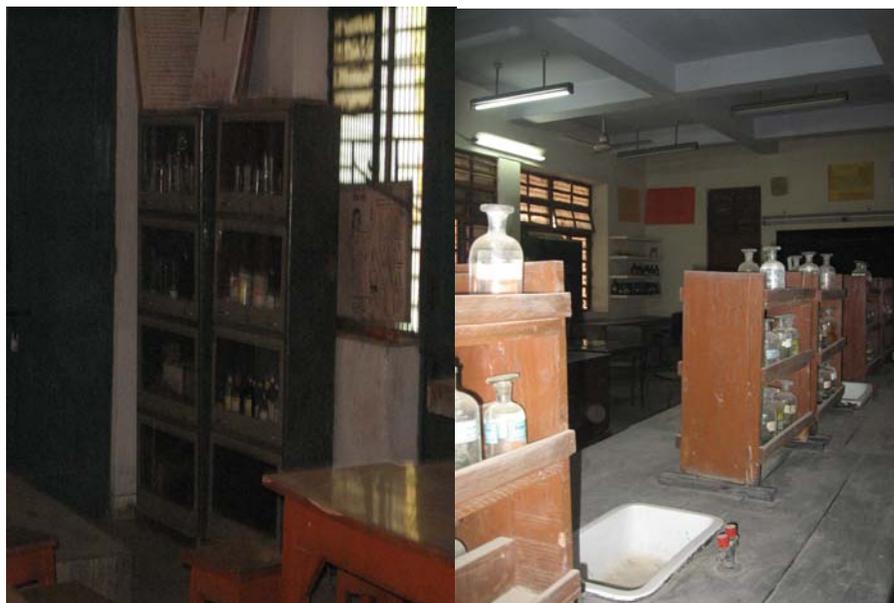
(a) Laboratories: Chemistry lab is in a separate room where as Biology & Physics are in the same room. The specimen, chemicals and the physics equipment are stored in the open on the table top. This makes the laboratory particularly vulnerable to fire / explosion during earthquakes. Maths, home science, social studies and geography have equipments kept every where. All of them also have 2-3 steel cupboards.

(Biology Lab)

(Chemistry Lab)

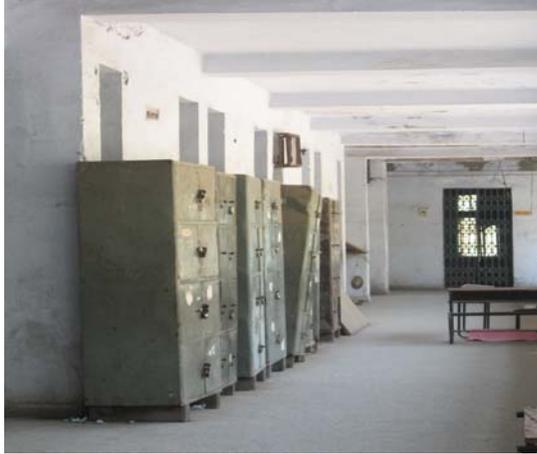
- (b) Library: There are two libraries in the whole school and the cupboards in which the library books are stowed have glass doors thereby increasing the hazards.
- (c) Corridor: The corridors are used as a storage area for the steel cupboards and they are also used for conducting classes hence benches are every where.

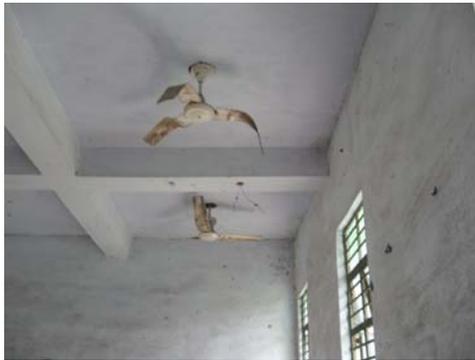
(d) Class rooms: The fans and light connections are vulnerable. The windows are broken. In the tin shed the Tin sheets are broken at many places

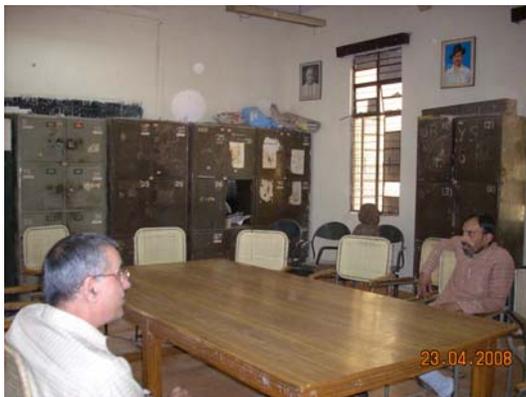
(f) Staff Room: All the walls of the staff room have cupboards lined up against them.

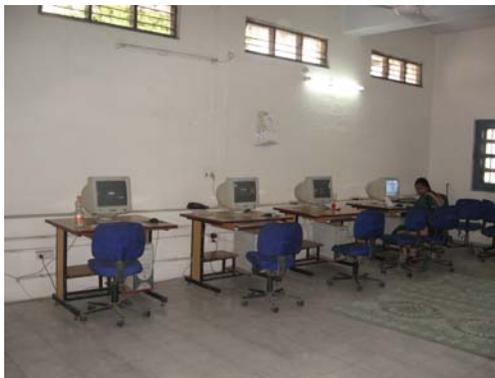
(a) Laboratories: Chemistry lab is in a separate room whereas Biology & Physics are in the same room. The specimen, chemicals and the physics equipment are stored in open on the table top. The presence of a number of LPG cylinders used for conduct of practical in home science lab increases the vulnerability of this compartment during disasters. However, the presence of a number of fire extinguishers stowed properly in the room reduces the risk to a certain degree. Maths, social studies and geography labs have equipments kept every where. All of them also have 2-3 steel cupboards.

(CAL Lab)

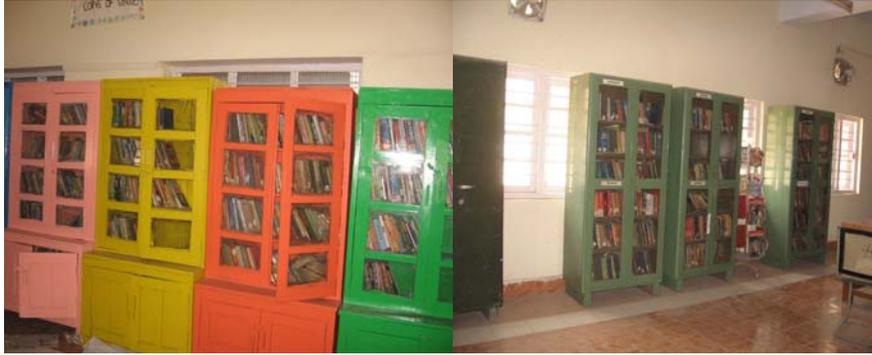
- (b) Library: The cupboards in which the library books are stowed have glass doors thereby increasing the hazards.

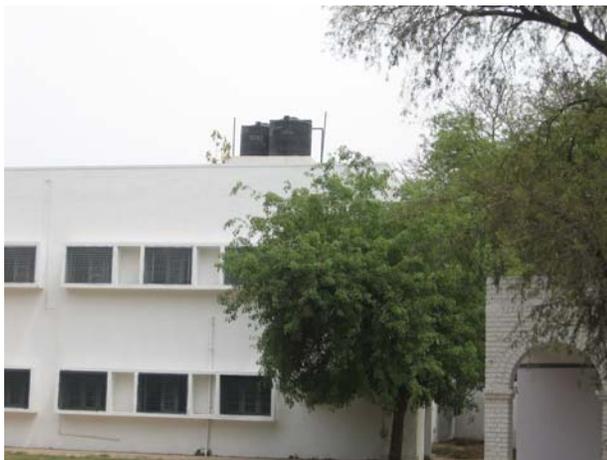
- (f) External Falling Hazards: The school has over head tanks for water (two on the building1 and one on the building 2).

(Over head tanks on building1)

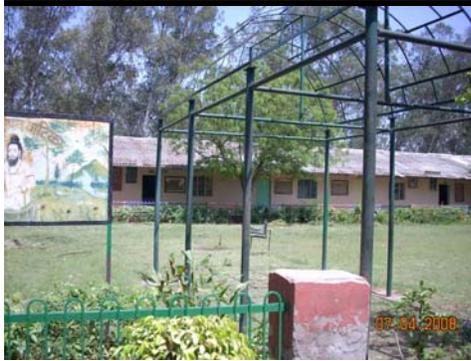
(Left of building 2)

The school has two open spaces. The one between buildings 2 and 4 is about 5 x 7 m. The other open space is 15 x 20 m on the right side of the building 2.

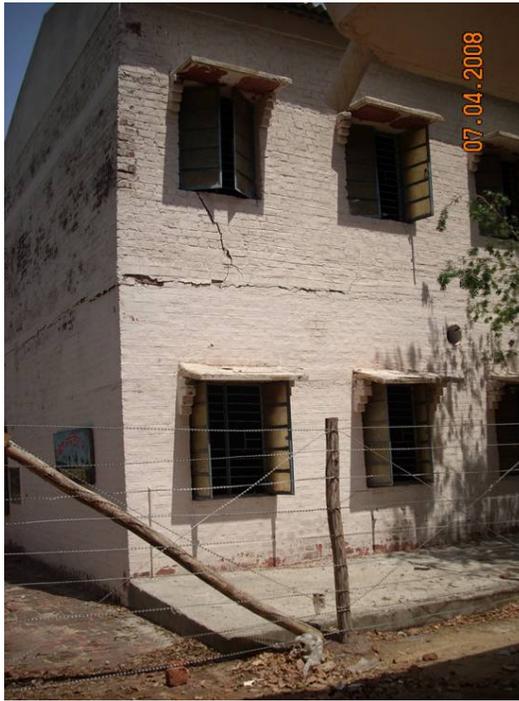
Building 1 looks to be in good condition. Building 2 which was inaugurated in 2003 had major cracks by 2004. That building is no longer in use and has fence on all sides.

(Building 2)

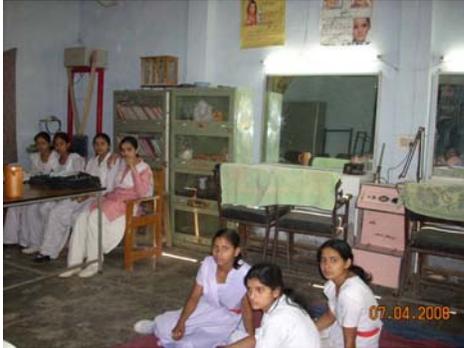
(a) Laboratories:. The presence of a number of LPG cylinders used for conduct of practical in the home science lab increases the vulnerability of this compartment during disasters. They also have typing and laboratories to train in beauty treatment. Maths, social studies and geography labs have equipments kept every where. All of them also have 2-3 steel cupboards.

(Beauty lab)

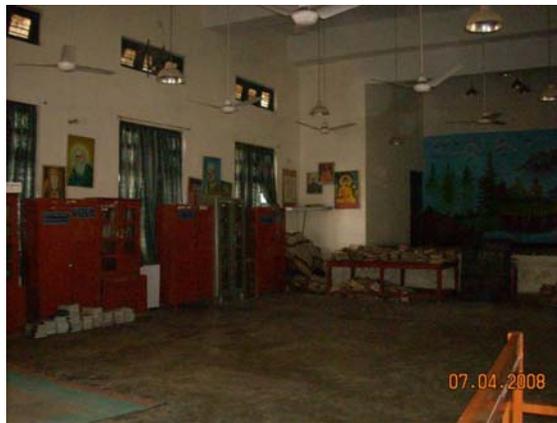
(b) Library: The library is inside the hall/ auditorium. The cupboards in which the library books are stowed have glass doors thereby increasing the hazards.

(Library/Hall)

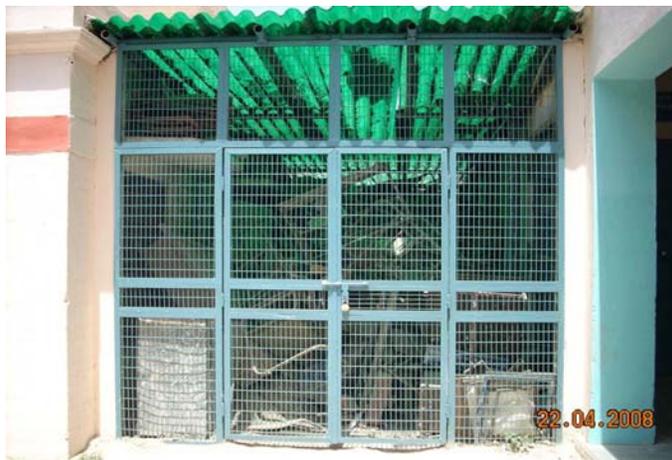
The main building and second pucca construction is 2m but a temporary construction joins them and is used as a storage space.

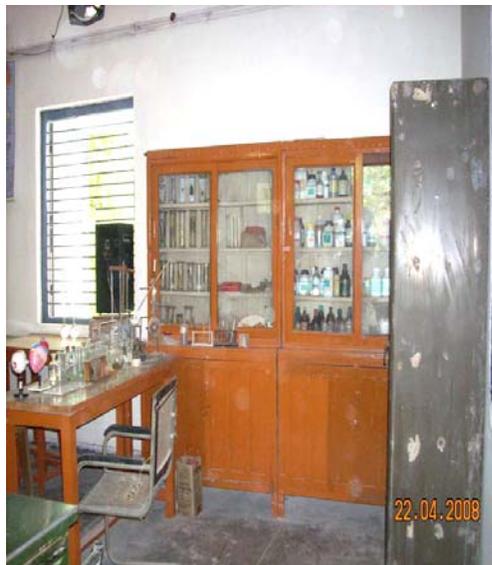
(a) Laboratories: Chemistry, Biology & Physics lab are in separate rooms and are different for both the schools. The specimen, chemicals and the physics equipment are stored in open on the top of the table. There are charts and other training aids all over the room. Maths, home science, social studies, geography and CAL laboratory have equipments kept everywhere . The school has a computer lab on the first floor of the main building. The CPU find their place on tables and one UPS sits next to the entrance. All of them also have 2-3 steel cupboards. This lab has few LPG gas cylinder for the purpose of practical.

(Chemistry Lab)

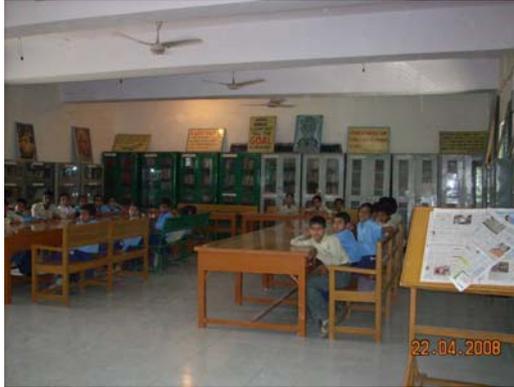
(b) Library: There are two libraries with 5500 books in the whole school and the cupboards in which the library books are stowed have glass doors thereby increasing the hazards.

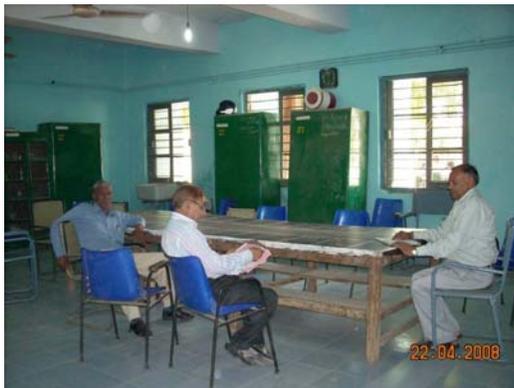
(f) Staff Room: All the walls of the staff room have cupboards lined up against them.

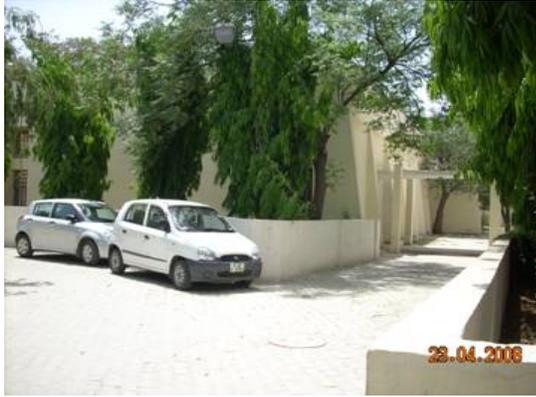
(The connection between the two buildings)

*The layout of the school:* The main building is 50 m away from the entrance of the school. The main building and the semi-pucca buildings are more than 5 m apart, connected by a 1m RCC corridor.

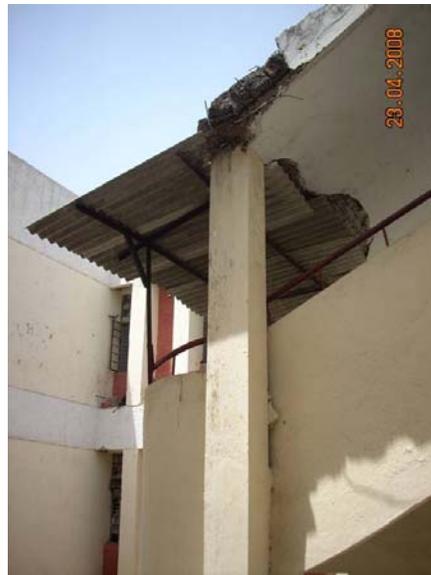
Building 1 has plaster falling at several places and the rusted rods are visible. The stairs are broken at most of the places. There is a gap of 2 feet between the boundary wall of the school and the left wall of Building 1.

(roof over the stair)

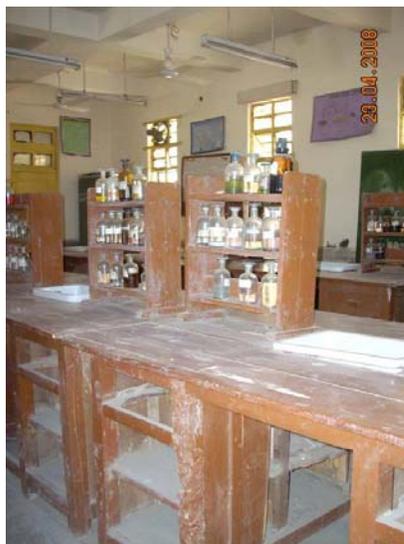
(a) Laboratories: Chemistry, Biology & Physics labs are in separate rooms and are different for both the schools. The specimen, chemicals and the physics equipment are stored in open on the top of the table. There are charts and other training aids all over the room. Maths, Home science, social studies, science lab (for 6<sup>th</sup> to 10<sup>th</sup>), Geography and CAL Laboratory have equipments kept everywhere. All of them also have 2-3 steel cupboards.

(Chemistry Lab)

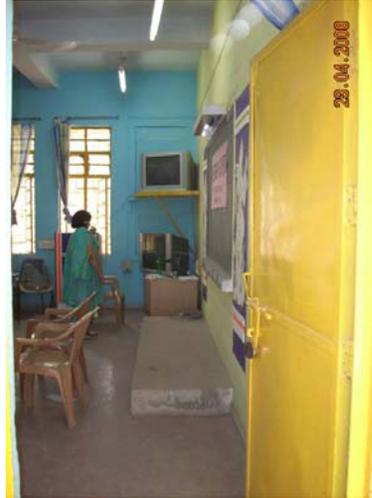
(e) Classrooms: The fans and light connections are vulnerable. Some rooms have televisions located on wall stands.

(Examination room)

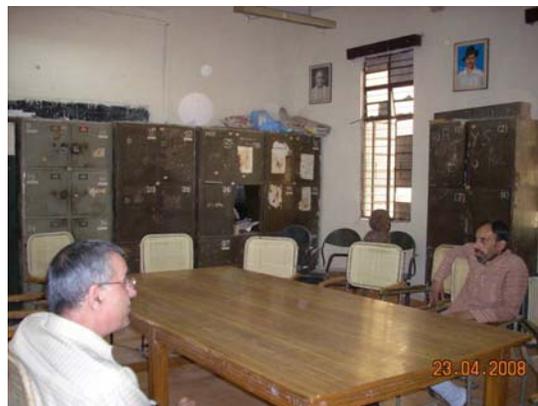
(g) Staff Room: All the walls of the staff room have cupboards lined up against them. They also have an LPG cylinder for the personal use.

(Staff Room)
